**COMPREHENSIVE MOTOR VEHICLE SERVICES AND
CONSULTING
MOTOR VEHICLE FORENSIC ANALYSIS
REPORT**

CMVSC-18-IA-245

-- In the Matter of the Death of Edson Thevenin --

INVOLVED DYNAMIC SUBJECT VEHICLE: 2000 Honda Civic EX Two Door Coupe

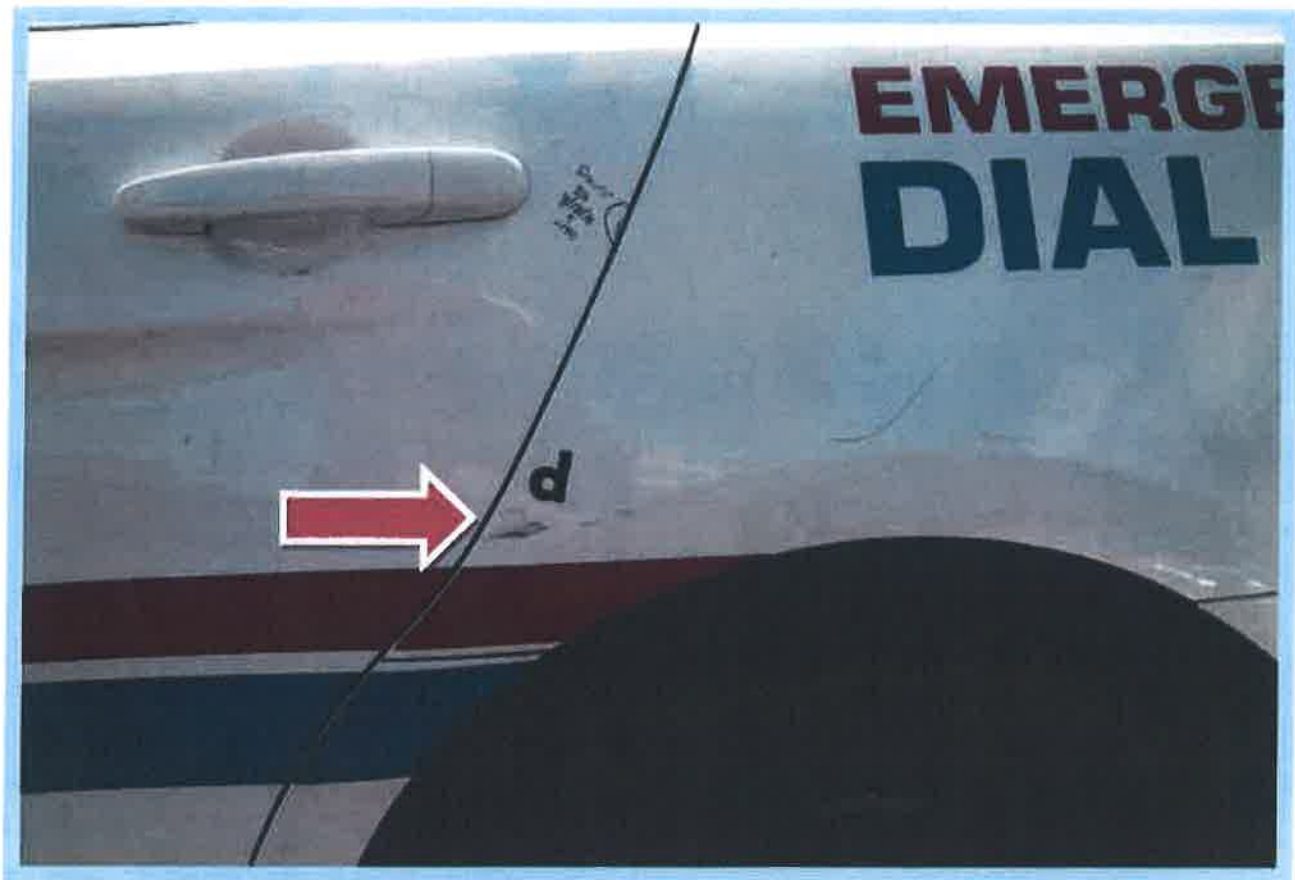
4) **Location of Damage:** Left Rear Quarter Panel, Forward Upper Wheel Well Area.

Description of Damage: Striations/scuffing/transfer.

Image No. 35 This photograph depicts the described damage present at the left rear quarter panel/upper dog leg area of the 2013 Ford Taurus. Note the obvious scuffing/transfer (Red Arrow).

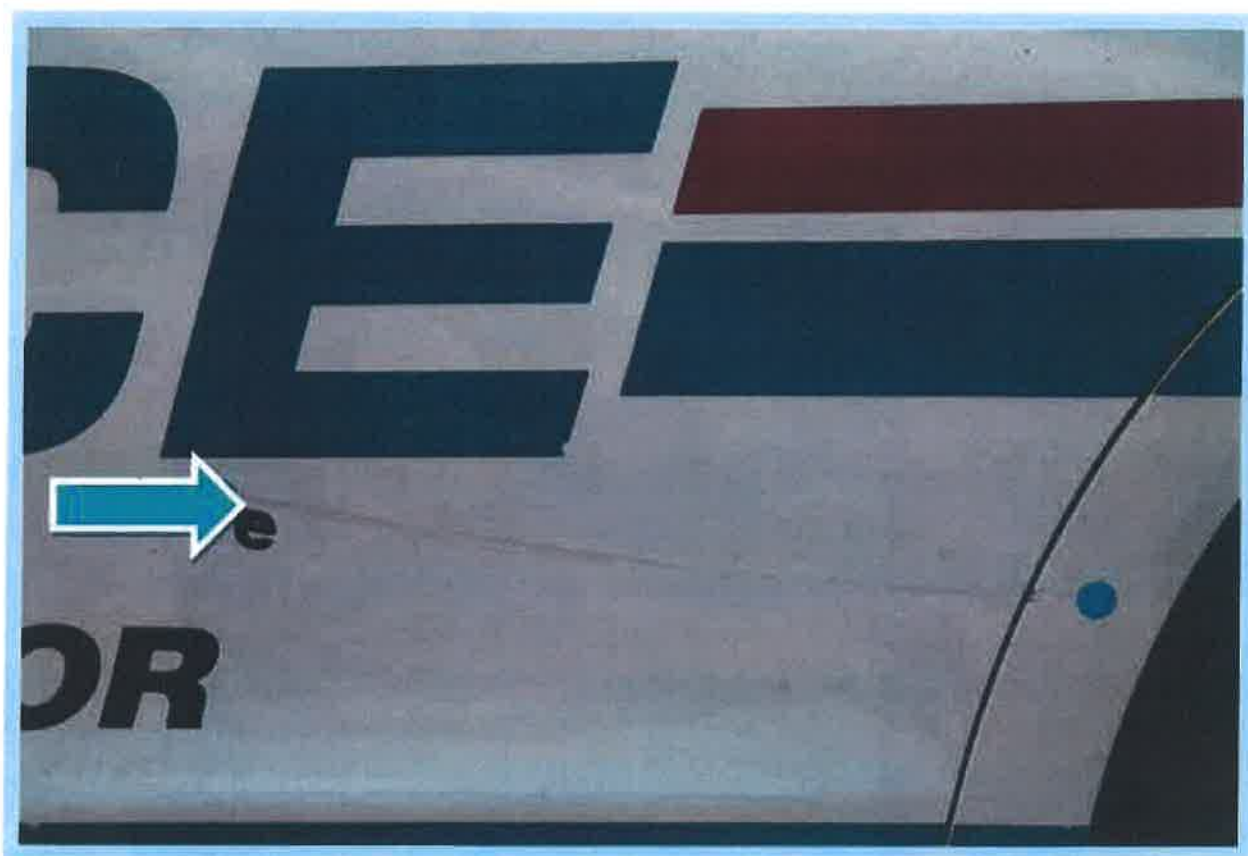
Image No. 30 This photograph depicts the described damage present at the left rear quarter panel of the 2013 Ford Taurus. Note the obvious scuffing/transfer (Blue Arrow).

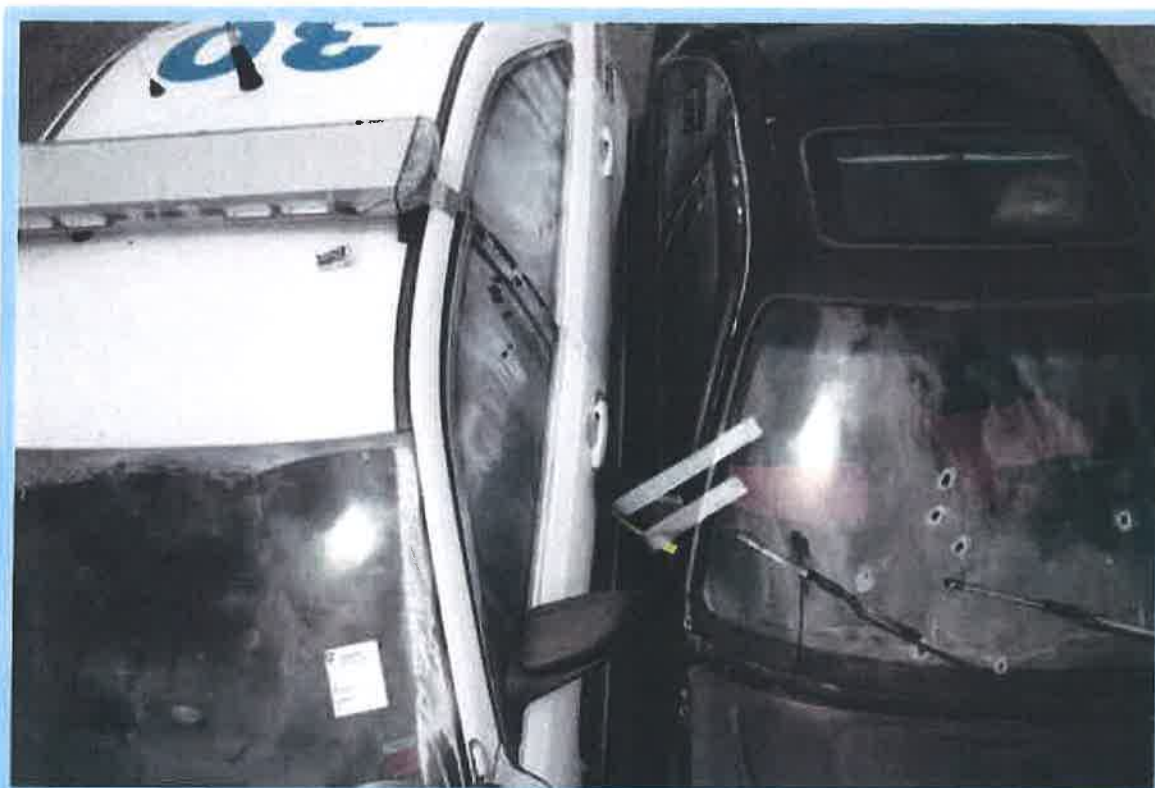
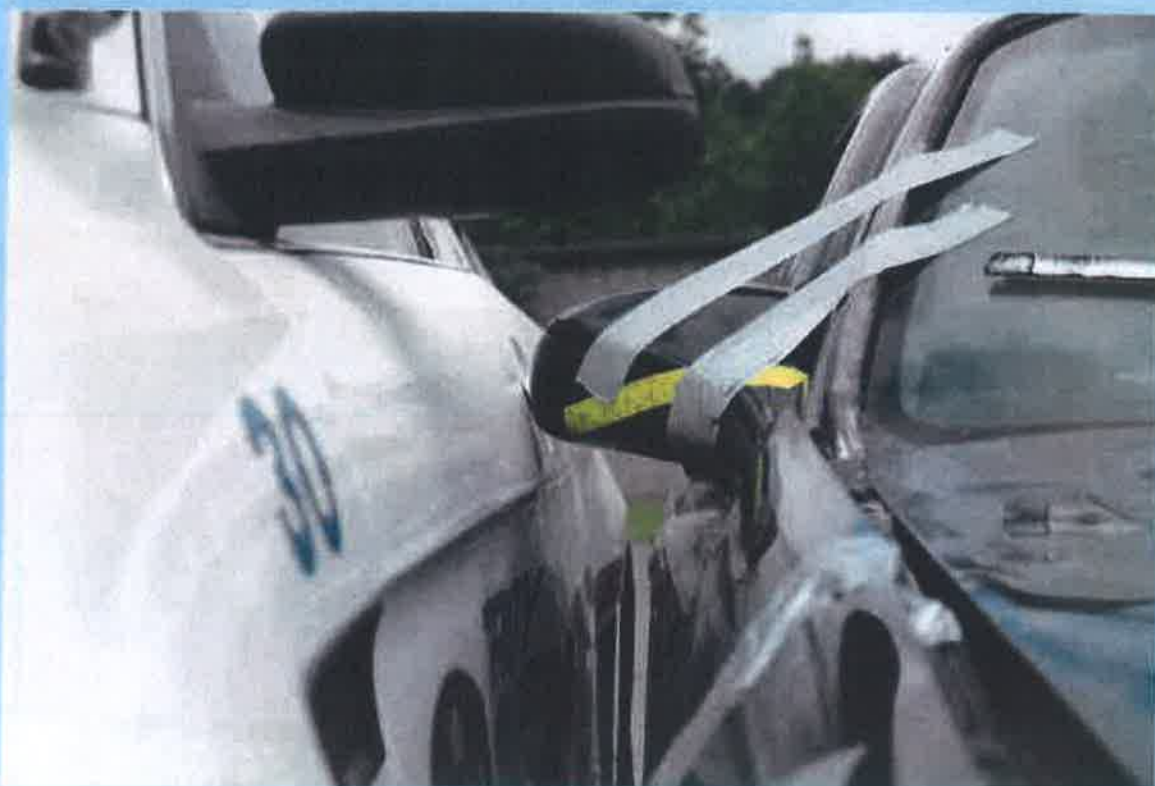
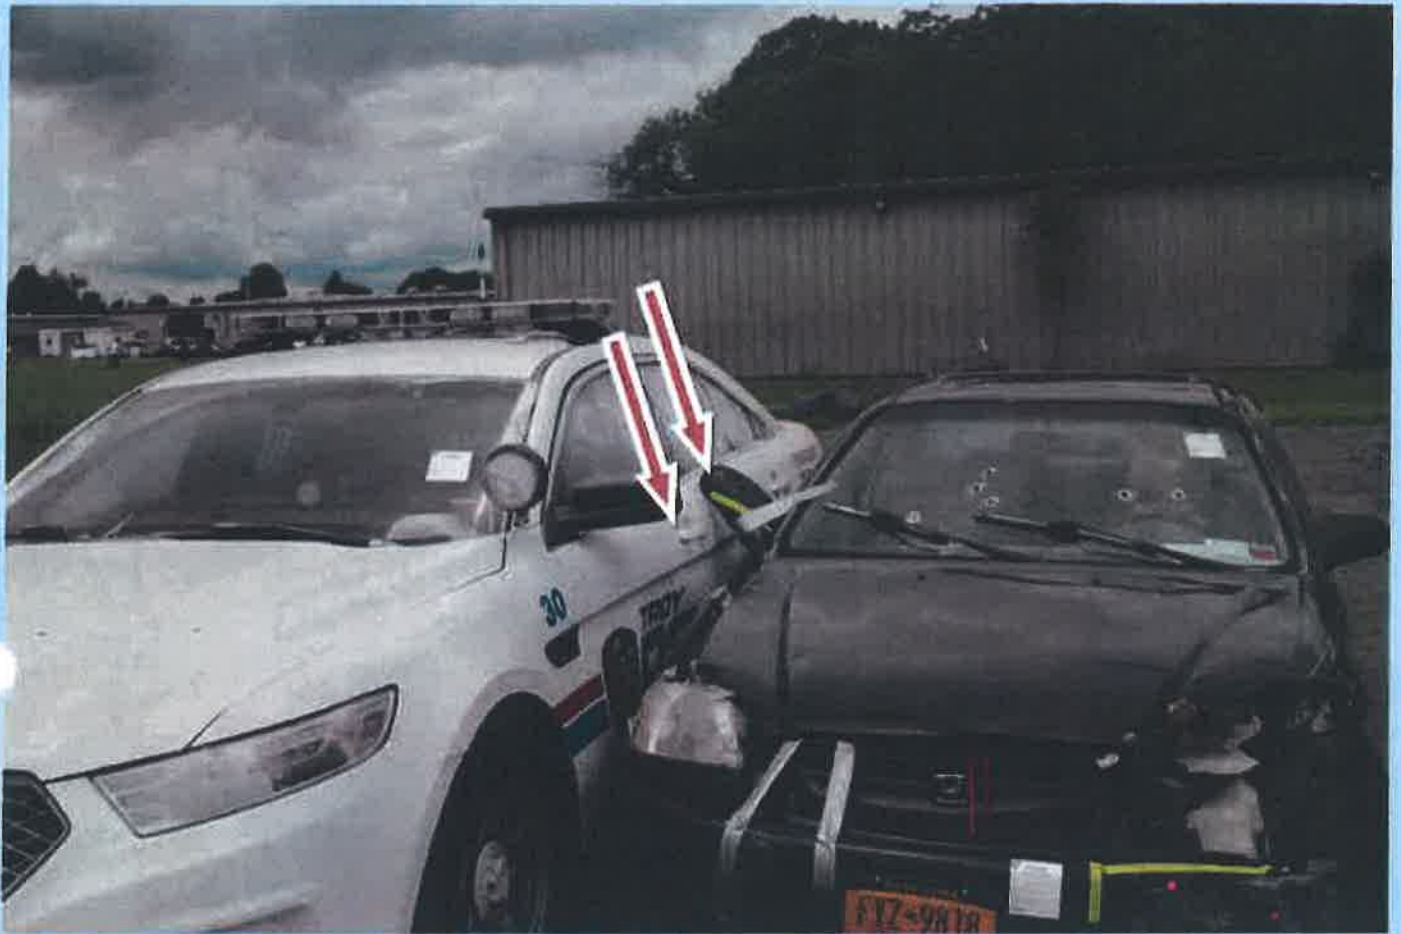
Images No. 37a, 37b, & 37c. These photographs (previous page and above) depict the forensic match-up of the scuff/transfer marks of the 2013 Ford Taurus with the 2000 Honda Civic right outside rearview mirror prior to and during detachment. The Red Arrows denote areas of black transfer and scuffing present on the Ford Taurus.

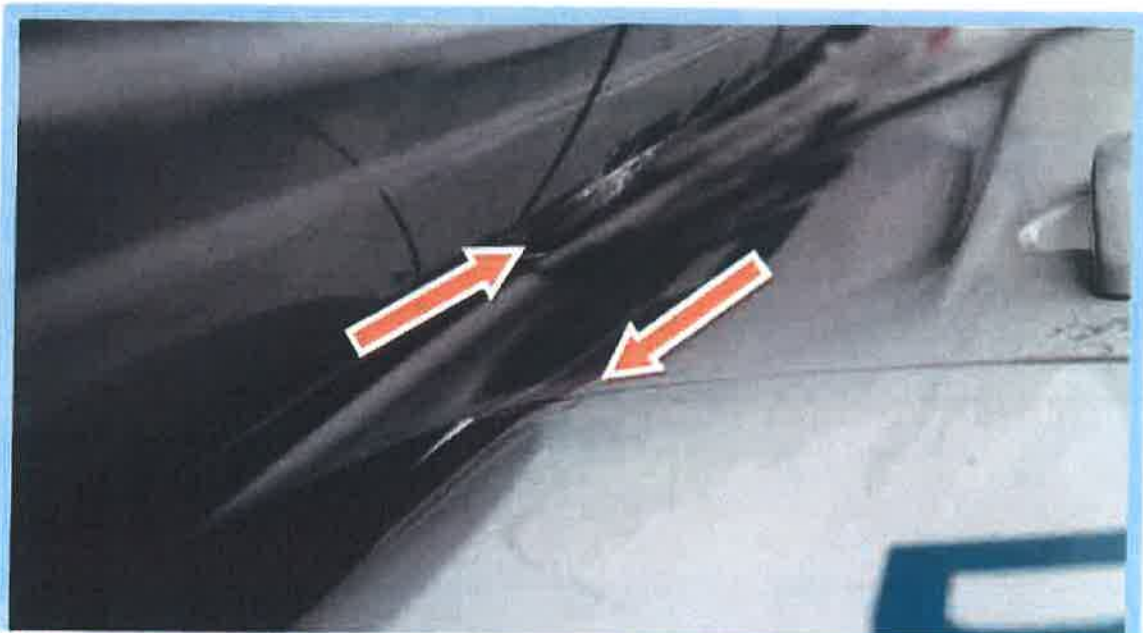
Image No. 38 The above photograph depicts the forensic matchup of the scuff transfer marks at the left rear forward quarter panel of the 2013 Ford Taurus with the right rear exterior door handle of the 2000 Honda Civic. The Orange Arrows denote the approximate contact areas.

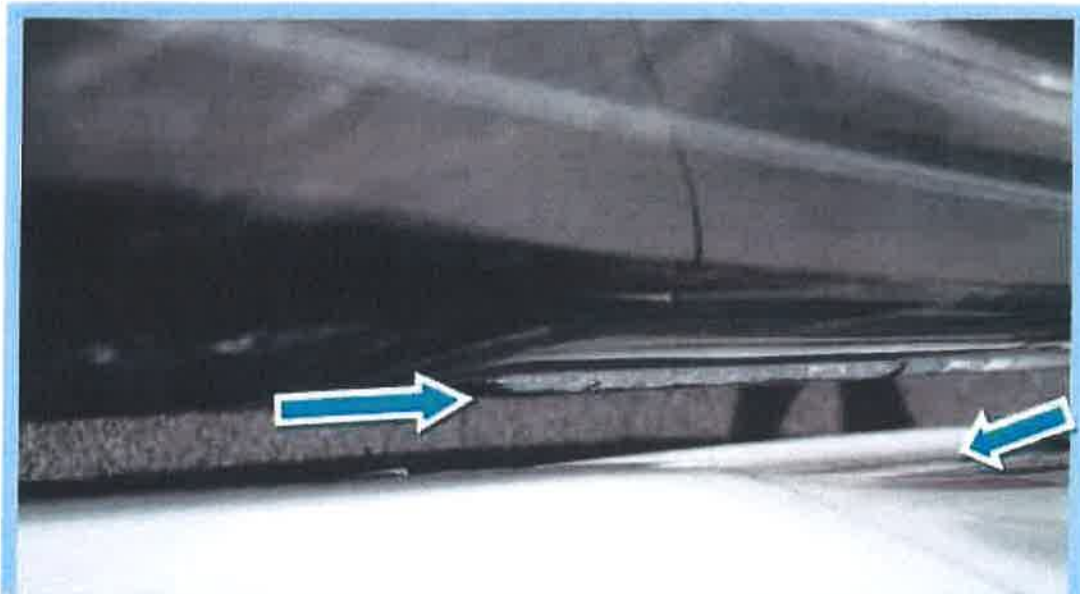
Image No. 39: The above photograph depicts the forensic matchup of the scuff/transfer marks of the left rear exterior door panel of the 2013 Ford Taurus with the right rear exterior side guard molding of the 2000 Honda Civic. The Blue Arrows denote the approximate contact areas.

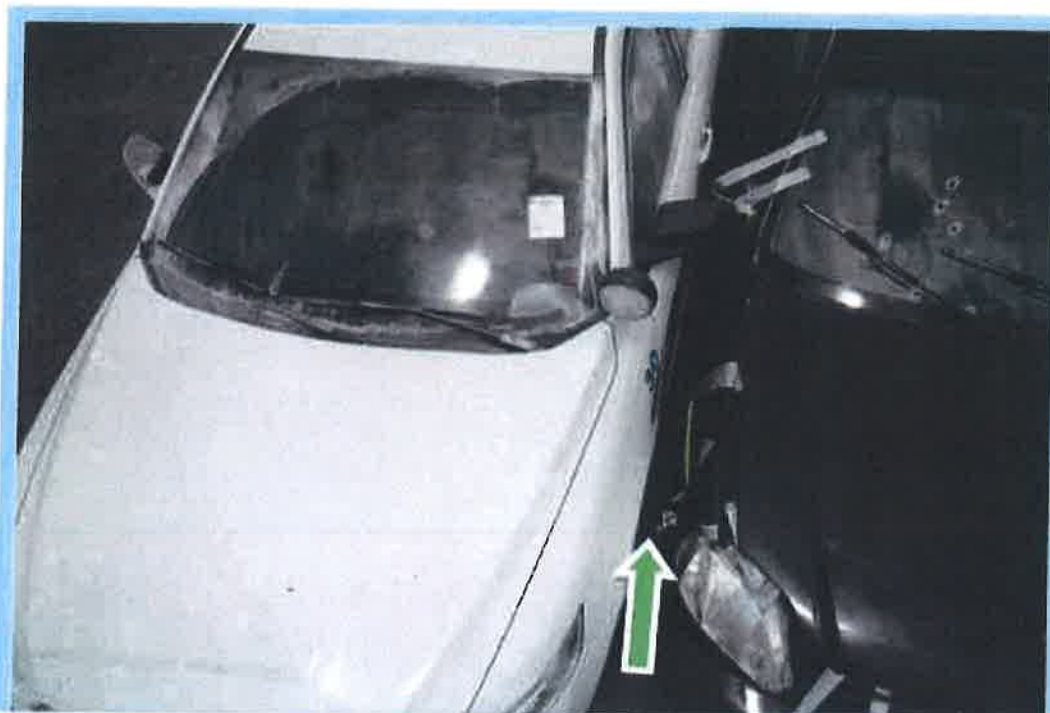
Image No. 49 The above photograph depicts the forensic matchup of the scuff transfer marks of the lower rear panel of the left front fender of the 2013 Ford Taurus with scuff transfer marks of the right side front bumper cover of the 2000 Honda Civic. The Green Arrow denotes the approximate contact event.

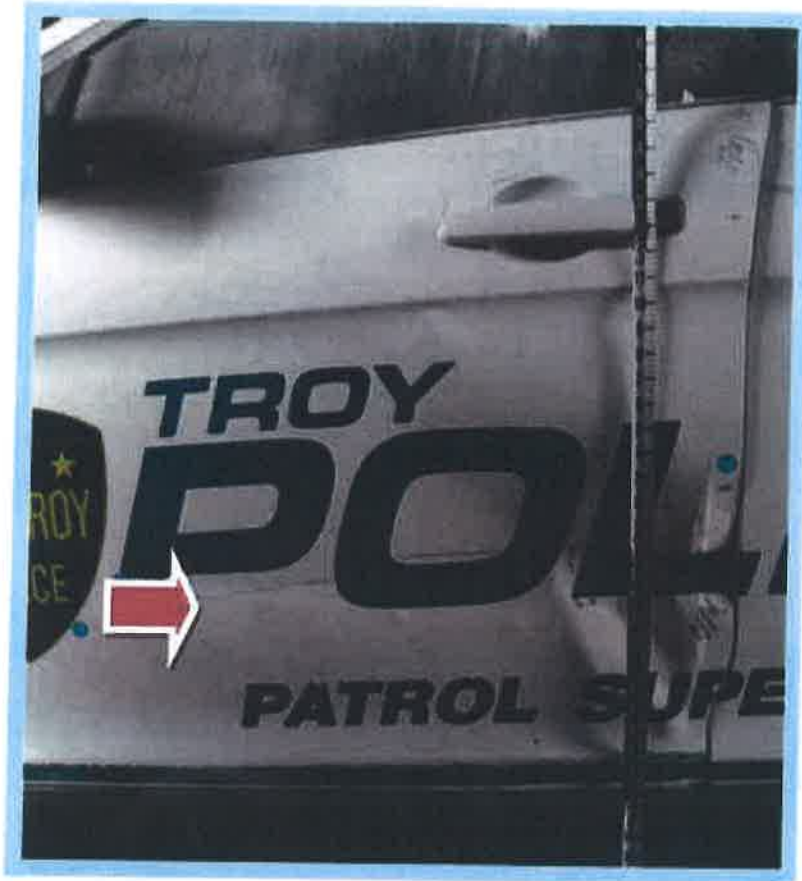
Images No. 41a & 41b These photographs depict the described damage present at the left front outer door panel of the 2013 Ford Taurus, and the right front outer fender panel of the 2000 Honda Civic. Note the matching scuffing transfer, as well as the height of the deformation damage resulting from forceful sliding impact. The Red Arrows denote the direction of the damage, with obvious increasing intrusion.

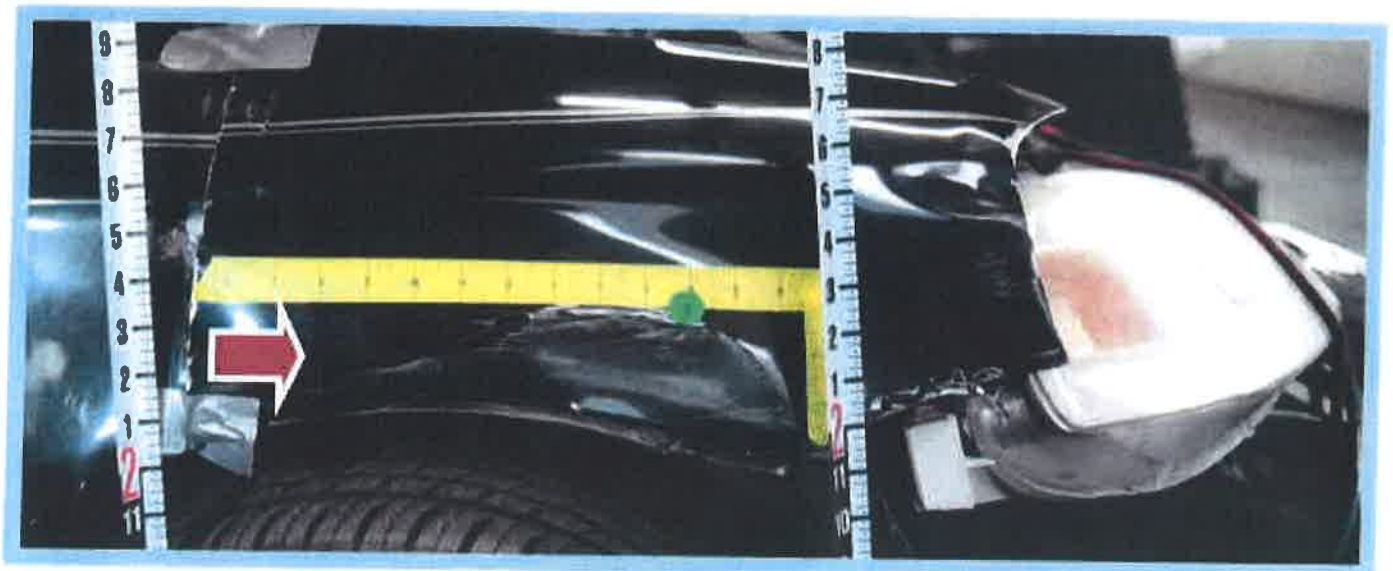
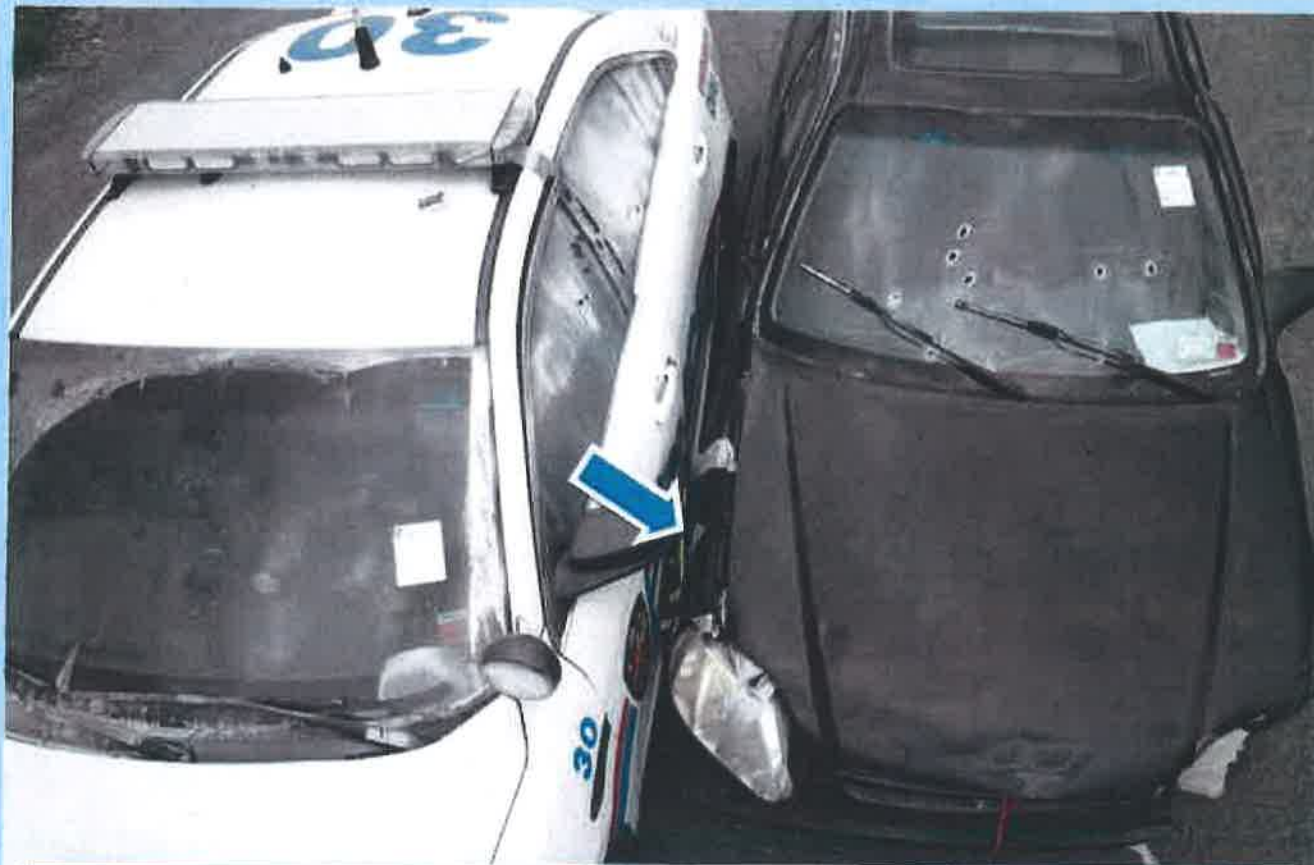
Images No. 42a & 42b These photographs depict the forensic damage matching of the 2013 Ford Taurus left front door and 2000 Honda Accord right front fender. The Blue Arrows denote the matched contact areas of the two motor vehicles. The directional damage is consistent with the white Ford Taurus traveling at the faster rate of speed.

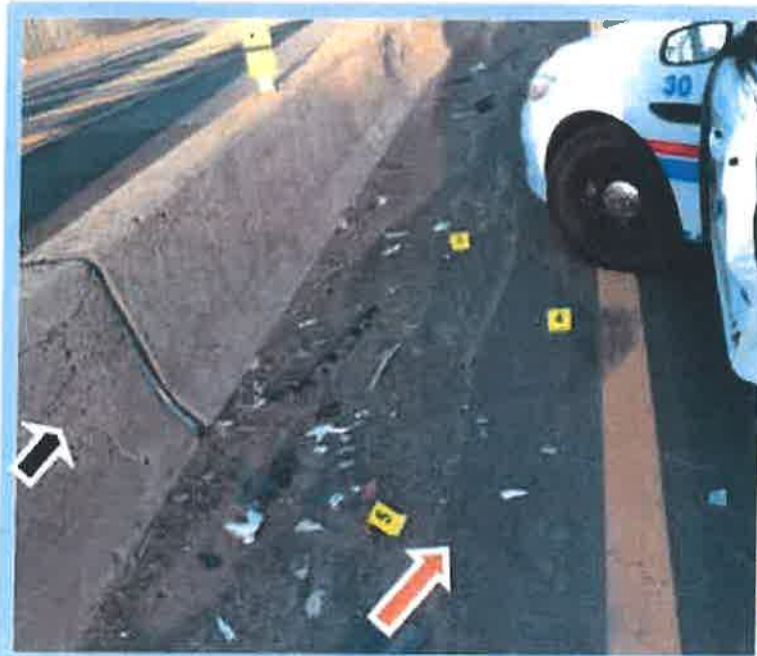
Image No. 46. This scene photograph depicts the scuff mark of the sideways sliding right front end of the involved 2000 Honda Civic (Orange Arrow) resulting from forced westerly trajectory of the front of the vehicle along the concrete barrier due to the severity of the barrier impact. The Black Arrow designates the corresponding physical evidence of the left frontal area of the 2000 Honda Civic during impact trajectory in a westerly direction along the concrete barrier to ultimate stopped vehicle location.

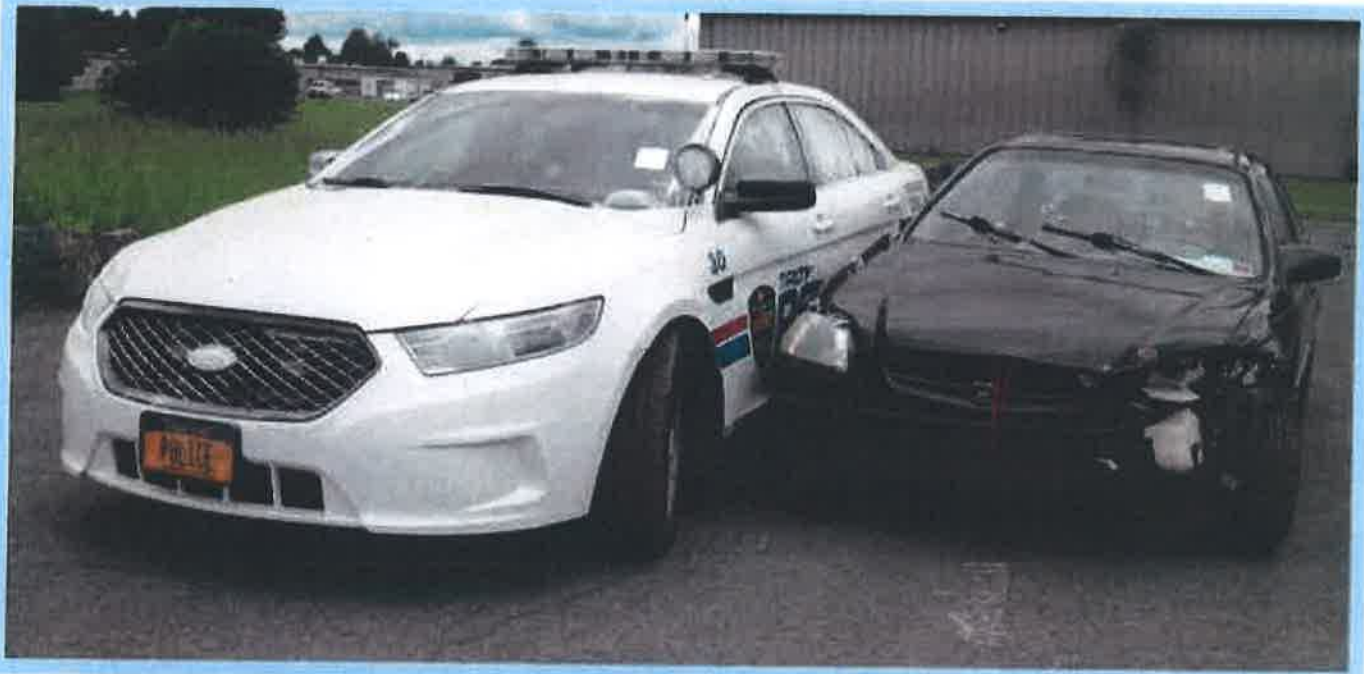
Image No. 47: This photograph, representing the sideswipe impact of the two involved vehicles at the approximate moment of Ford Taurus left front door Honda Civic right front fender contact damage matchup, depicts the comparison of the overall size of the 2013 Ford Taurus (left) and the 2000 Honda Civic (right). Digital scale weighing of the two vehicles revealed that the 2013 Ford Taurus weighed some 1409 lbs. more than the 2000 Honda Civic (without operators).
